Use Attainability Analysis
for
Water Body Identification # 0187
Coon Creek

Conducted by:
Environmental Resources Coalition

To:
Missouri Department of Natural Resources
Water Protection Program

Stream Description – WB ID: 0187 – Coon Creek

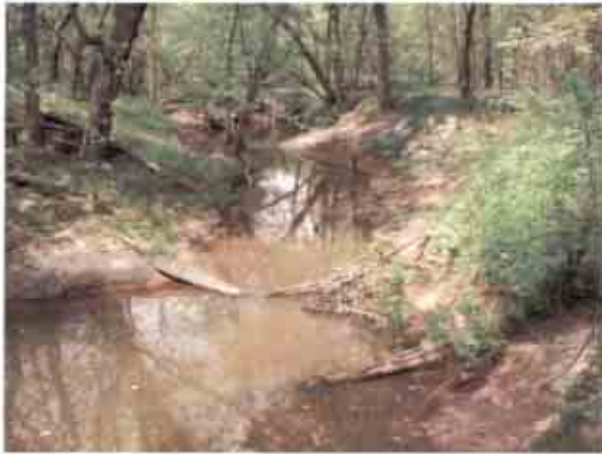
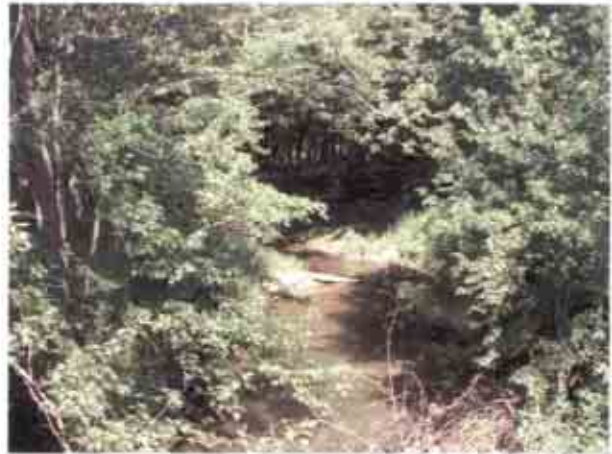
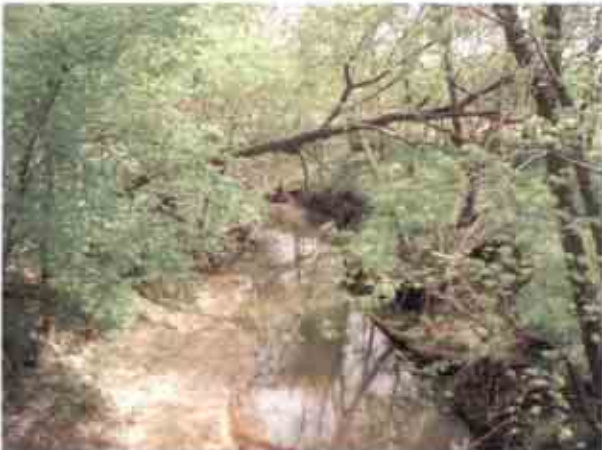
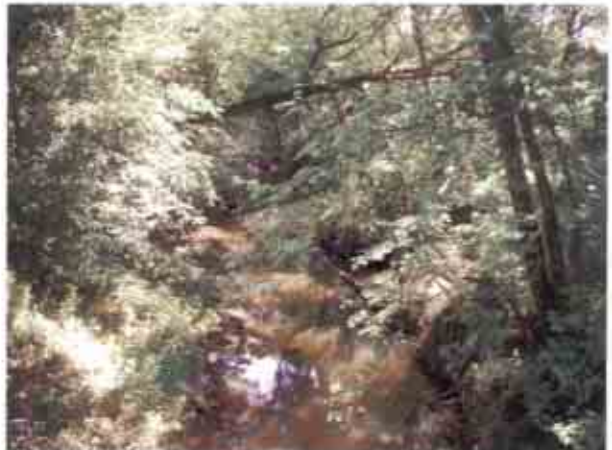
Site # 1 - Morgan School Road

04/25/05	06/07/05
Assessment Location	Upstream	Upstream
Time	11:30 AM	10:55 AM
Stream Type	Pool	Pool
Width (m)	5.79	6.55
Length (m)	15.24	15.24
Ave Depth (cm)	41.25	46.58
Maximum Depth (cm)*	68.0	73.0
Flow Present	No	No
Flow (cfs)	-	-

Uses Observed	None	None
Evidence of Human Use (WBCR)	None	None
Aquatic Vegetation	None	Algae

Odor	None	None
Color	Turbid, tea colored	Turbid, tea colored
Bottom Deposits	None	None
Surface Deposits	None	None

Site #1: Site #1 of Coon Creek is located on Morgan School Road and is the uppermost assessment site of the classified reach. Wooded areas surround the stream at this site. The water is turbid and tea-colored, and there is a great deal of woody debris throughout the site. The banks are steep and brush covered making access to the stream difficult.

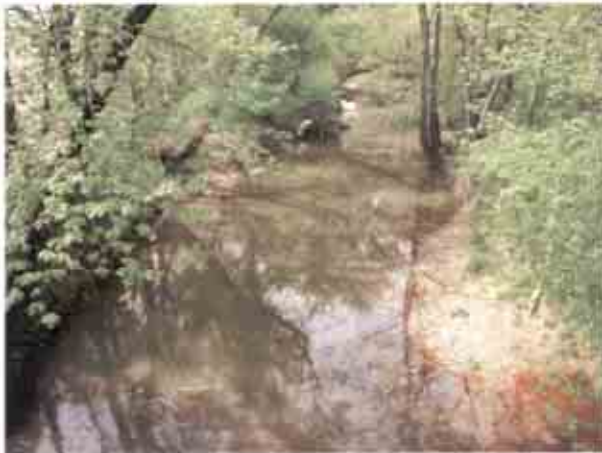
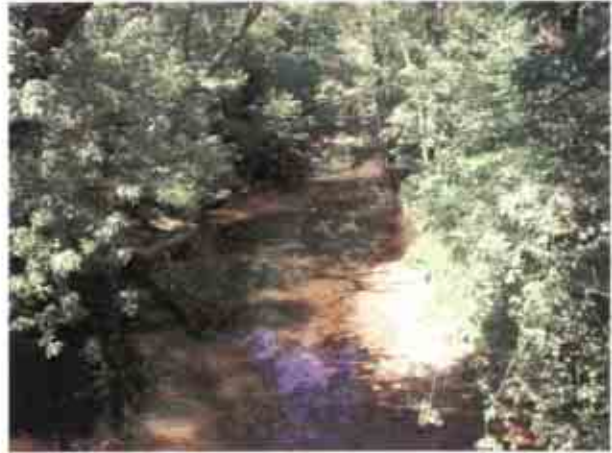
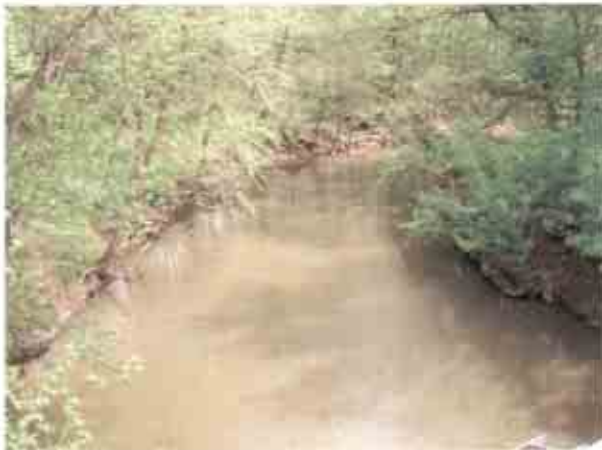
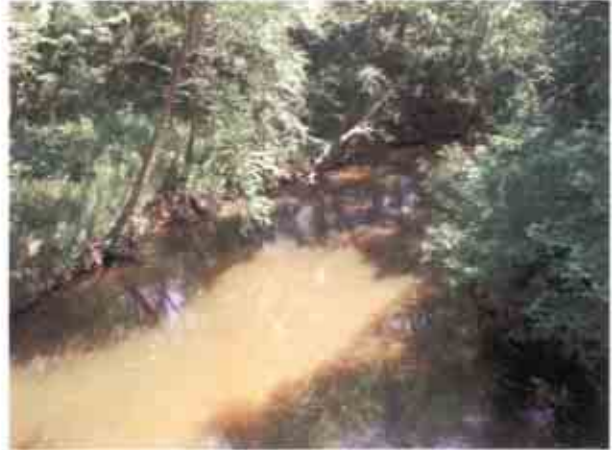
Site # 2 - Swoop School Road

04/25/05	06/07/05
Assessment Location	Upstream	Upstream
Time	11:52 AM	11:10 AM
Stream Type	Run	Run
Width (m)	9.45	10.36
Length (m)	30.48	30.48
Ave Depth (cm)	32.17	25.94
Maximum Depth (cm)*	57.0	41.0
Flow Present	Yes (very slow)	Yes (very slow)
Flow (cfs)	-	-

Odor	None	None
Color	Turbid	Turbid / tea colored
Bottom Deposits	None	None
Surface Deposits	None	Oily film

Site #2: Site #2 of Coon Creek is located on Swope School Road. Wooded areas surround the stream at this site. Banks are steep and brush covered making access to the stream difficult. Woody debris is very prevalent in the water at this site.

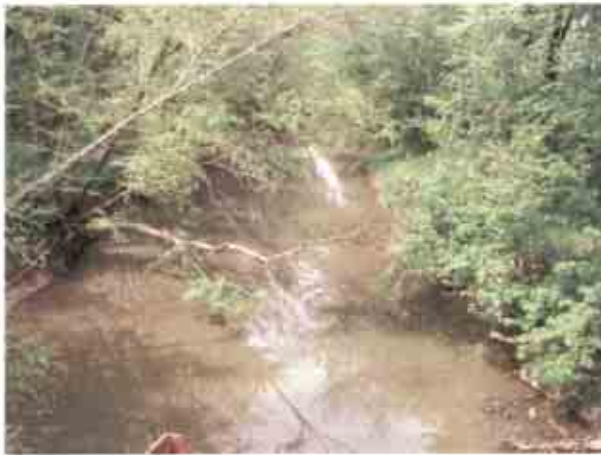
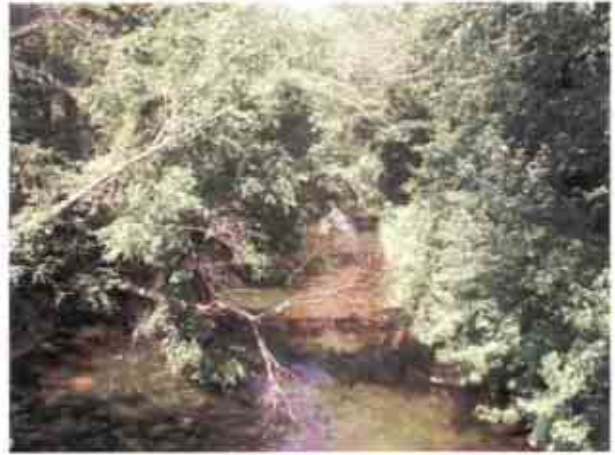
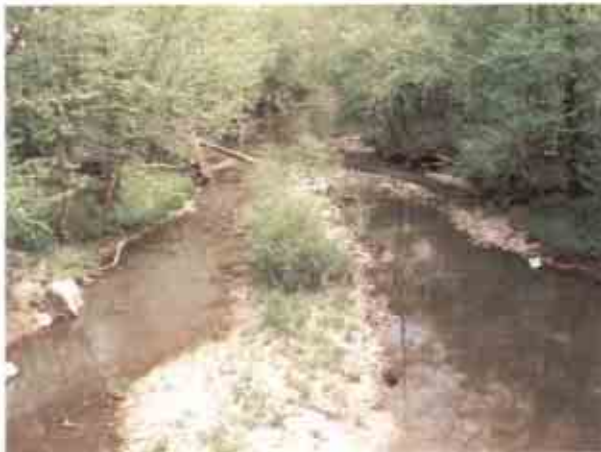
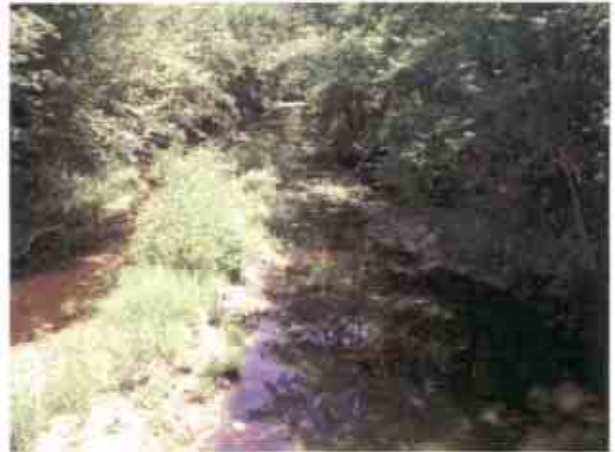
Site # 3 - Coon Creek Road

04/25/05	06/07/05
Assessment Location	Downstream	Downstream
Time	12:10 PM	11:24 AM
Stream Type	Run	Run
Width (m)	13.72	17.69
Length (m)	60.96	60.96
Ave Depth (cm)	21.75	15.23
Maximum Depth (cm)*	32.0	40.0
Flow Present	Yes	Yes
Flow (cfs)	-	-

Uses Observed	None	None
Evidence of Human Use (WBCR)	None	None
Aquatic Vegetation	None	Floating mats of algae, algae on rocks
<i>Water Characteristics</i>		
Odor	None	None
Color	Turbid	Turbid
Bottom Deposits	None	None
Surface Deposits	None	None

Site #3: Site #3 of Coon Creek is located on Coon Creek Road. At this site, the banks are steep and brush covered making access to the stream difficult. Wooded areas and farm fields surround the stream at this site. The water is very turbid with foam on the surface. There are floating mats of algae, along with thick periphyton growth on the rocks. Woody debris is widespread throughout the site, and the stream has a very slow flow.

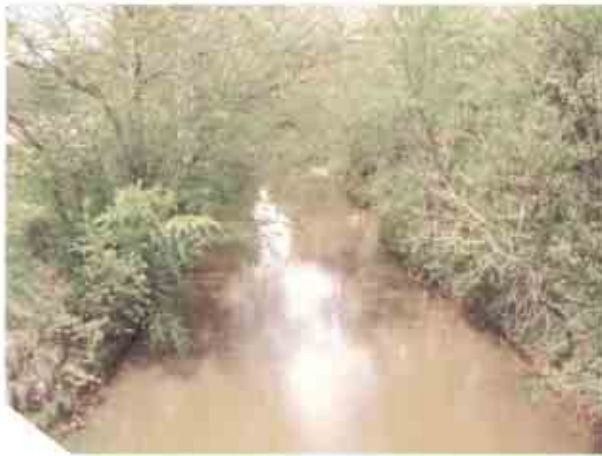
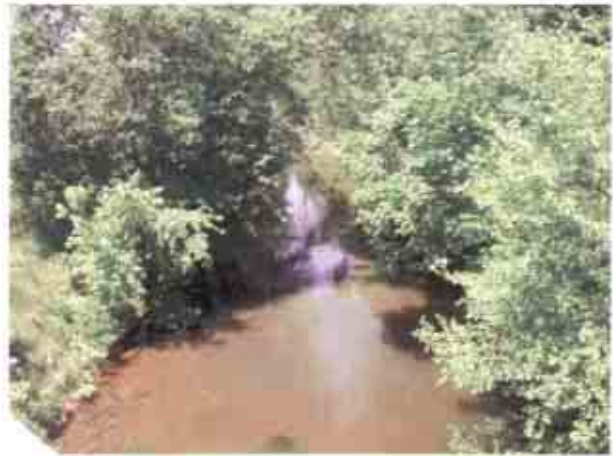
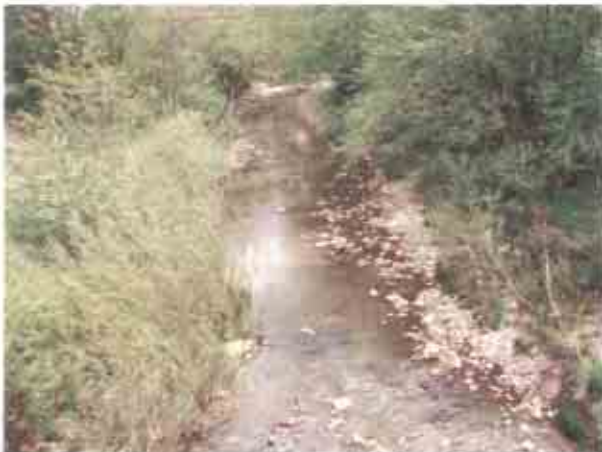
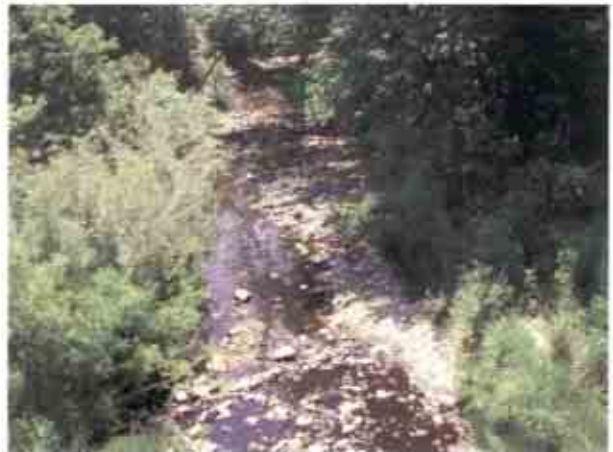
Site # 4 - Highway 161

04/25/05	06/07/05
Assessment Location	Upstream	Upstream
Time	12:25 PM	11:34 AM
Stream Type	Run	Run
Width (m)	11.89	10.06
Length (m)	45.72	45.72
Ave Depth (cm)	27.86	16.58
Maximum Depth (cm)*	53.0	34.0
Flow Present	Yes	Yes
Flow (cfs)	-	-

Uses Observed	None	None
Evidence of Human Use (WBCR)	None	None
Aquatic Vegetation	Filamentous algae	Filamentous algae 40%

Site #4: Site #4 of Coon Creek is located at the Highway 161 bridge at the southwestern edge of the Middletown city limits. Farm fields line one side of the water body, wooded areas and houses line the opposite side. The creek banks within the Highway 161 road easement are not as steep or brush covered as the other assessment sites on Coon Creek.

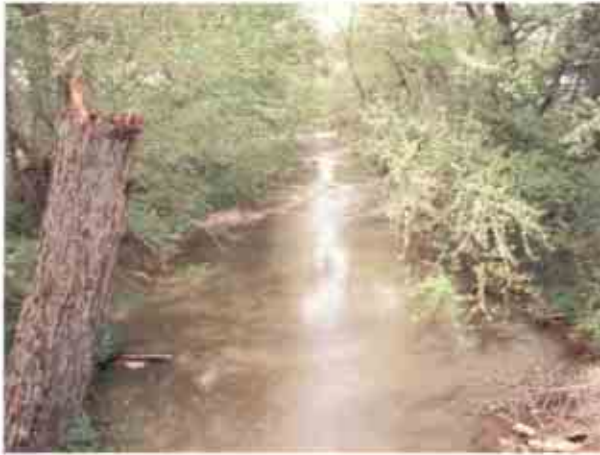
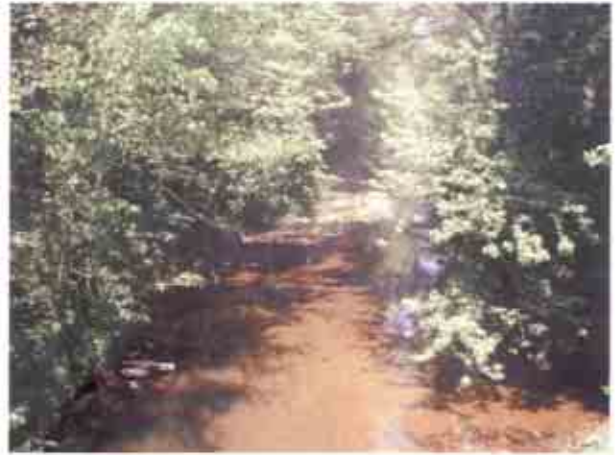
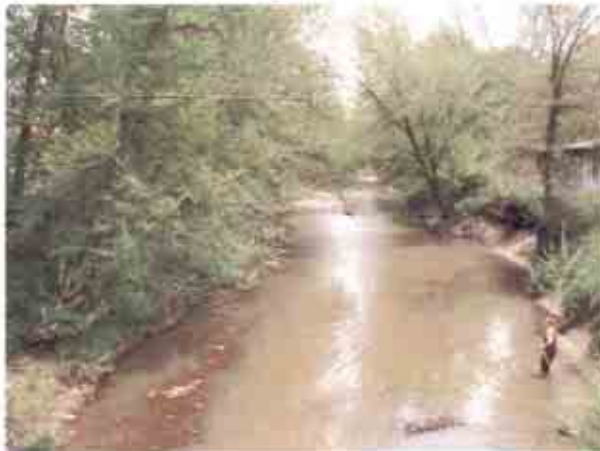
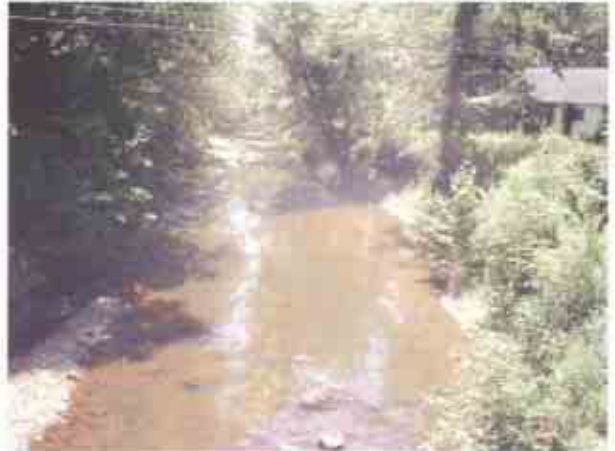
Site # 5 - Freemount Road

04/25/05	06/07/05
Assessment Location	Downstream	Downstream
Time	12:40 PM	11:50 AM
Stream Type	Run	Run
Width (m)	12.80	7.92
Length (m)	15.24	15.24
Ave Depth (cm)	34.89	19.29
Maximum Depth (cm)*	66.0	37.0
Flow Present	Yes	Yes
Flow (cfs)	-	-

Odor	None	None
Color	Turbid	Clear
Bottom Deposits	None	None
Surface Deposits	None	Oily film in places

Site #5: Site #5 of Coon Creek is located on Freemount Road, just south of the Middletown city limits. Wooded areas surround the stream at this site. The banks are steep and brush covered making access to the stream difficult.

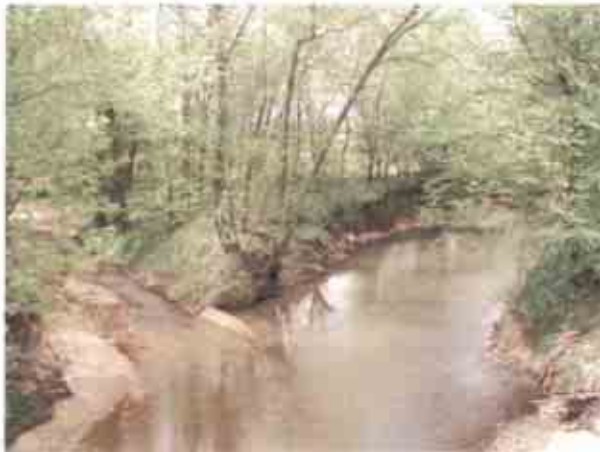
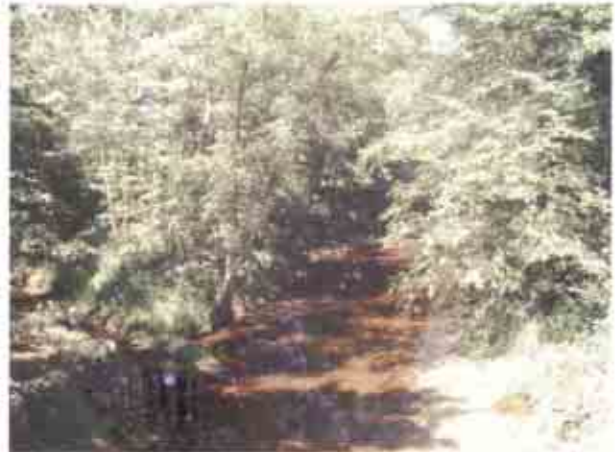
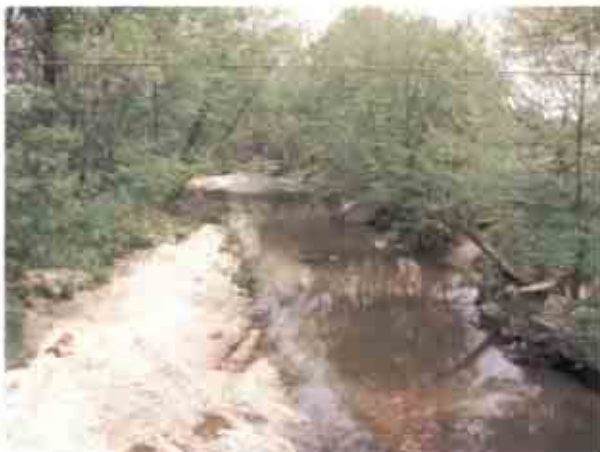
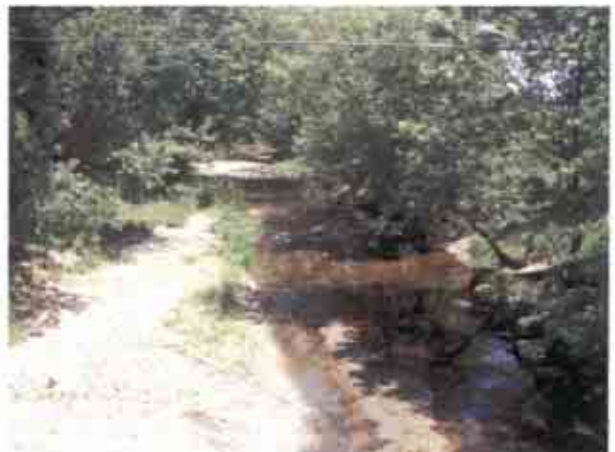
Site # 6 - Post Oak School Rd.

04/25/05	06/07/05
Assessment Location	Upstream	Upstream
Time	12:50 PM	11:48 AM
Stream Type	Run	Run
Width (m)	8.23	8.84
Length (m)	76.20	76.20
Ave Depth (cm)	12.00	23.00
Maximum Depth (cm)*	31.0	45.0
Flow Present	Yes	Yes
Flow (cfs)	-	-

Odor	None	None
Color	Lightly turbid	Slightly turbid
Bottom Deposits	None	None
Surface Deposits	None	Foam, oily film

In the upstream view picture, Coon Creek is the larger stream to the right.

Site #6: Site #6 of Coon Creek is located on Post Oak School Road, just south of the Middletown city limits, and is the only site below the Middletown City Lagoon outfall. Pastures, wooded areas, and cropland surround the stream at this site.
